Five-Year Review Report Pursuant to CERCLA

Third Five-Year Review Report Northernaire Plating Superfund Site Cadillac, Wexford County, Michigan

U.S. Environmental Protection Agency Region 5 Chicago, Illinois

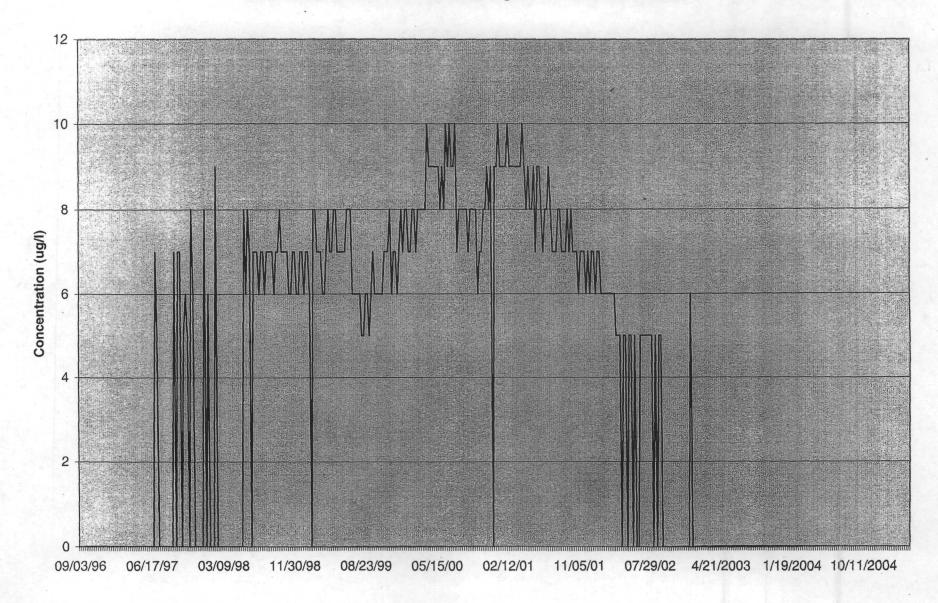
Hexavalent Chromium in Discharge from Treatment Plant

- <u>Clam River Discharge Samples</u>: System has been in compliance since 2001
 The limit for the concentration of hexavalent chromium in the effluent is a monthly average of 8.3 ug/l. Samples are collected weekly. This limit has not been exceeded, on a <u>per sample</u> basis, since August 2001. Since March 2003, effluent results have been non-detect for hexavalent chromium. The last violation of the hexavalent chromium discharge limit occurred in December 2000. During December 2000, when the exceedence occurred, the average monthly concentration was 9.33 ug/l; the highest concentration during the month was 10 ug/l.
